Use Attainability Analysis
for
Water Body Identification # 3094
Ditch # 8

Conducted by:
Environmental Resources Coalition

Stream Description – WB ID: 3094 – Ditch #8

WB # 3094 – Ditch # 8

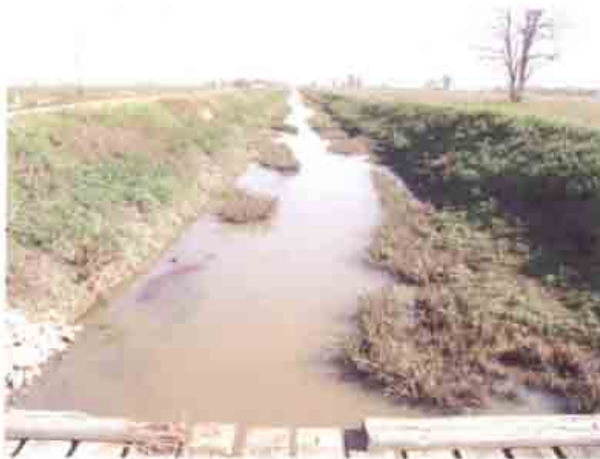
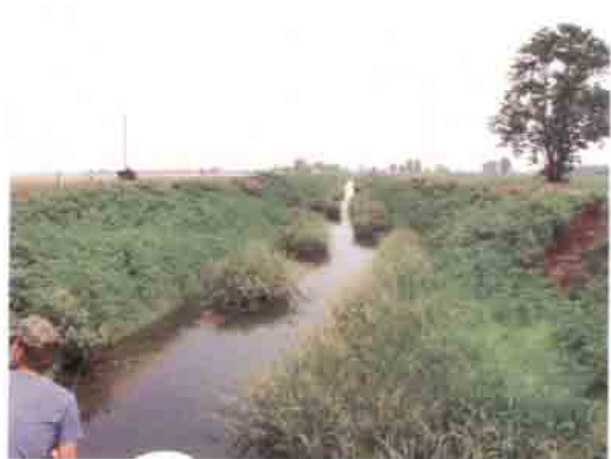
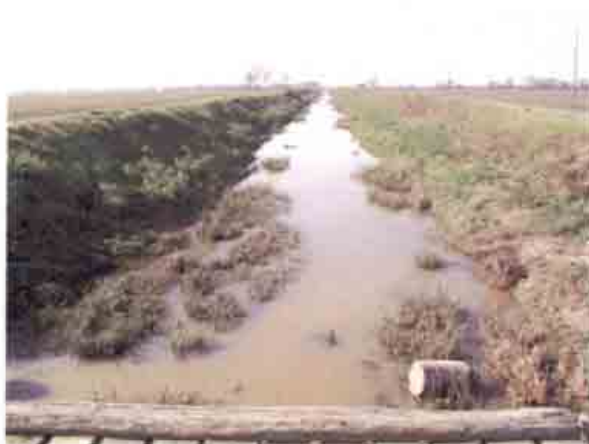
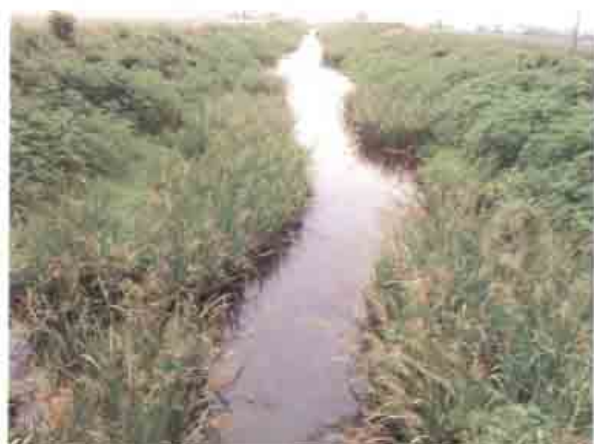
Site # 1 - Jct of Co Rd 240 & Co Rd 242

Site #1: Site #1 of Ditch #8 is located at the junction of County Road 240 and County Road 242. This is the lowermost site of the reach and is downstream from the City of Risco Waste Water Treatment Facility. Steep banks and occasional dense plant growth make access to the water body difficult. Farm fields surround the area. A large amount of garbage, including appliances, mattresses, barrels, and barbeque grills, has been dumped in the water body. Surface deposits were observed during each visit to this site (April 16th oily residue, and June 3rd foam).

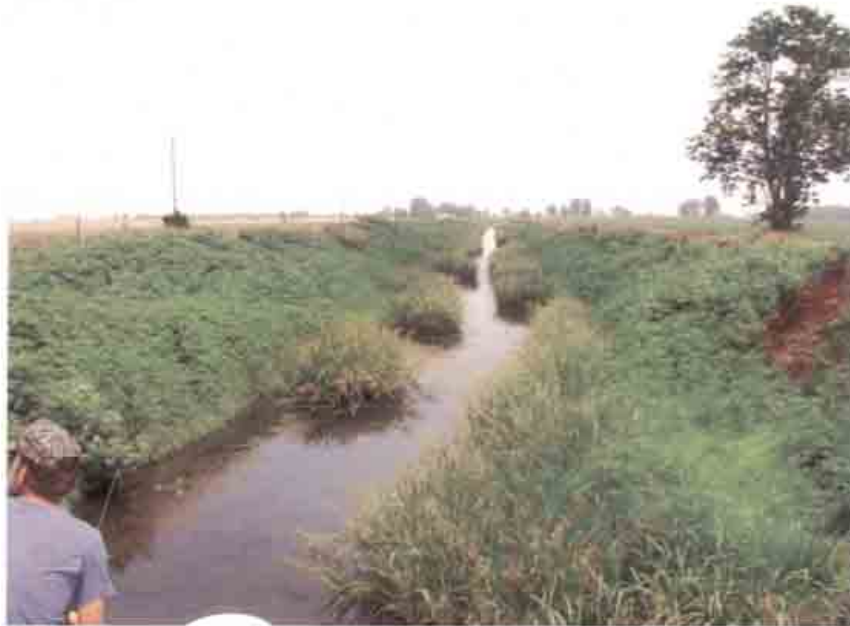
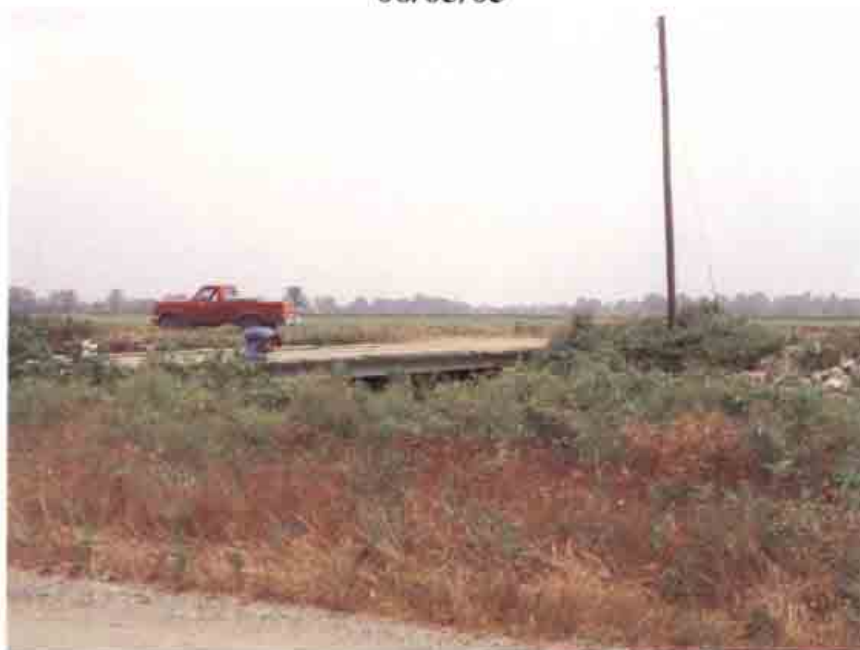
06/03/05

The above pictures are of a man fishing using both pole and line and trotline methods. He stated that he comes to the water body a few times a summer to fish. He also noted that he is fully aware that the WWTF discharges into the stream.

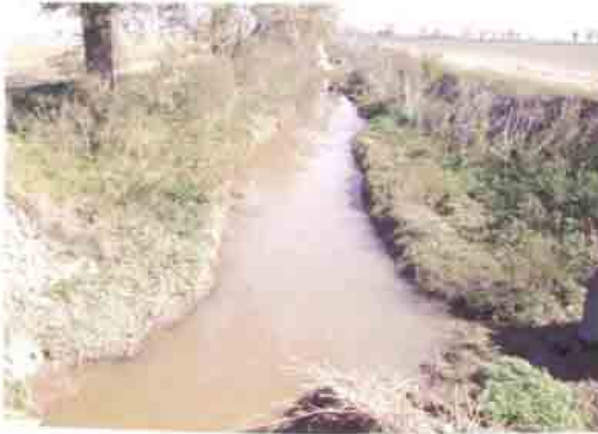
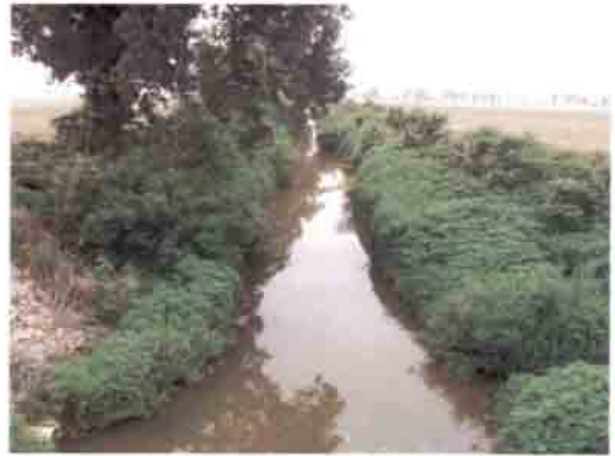
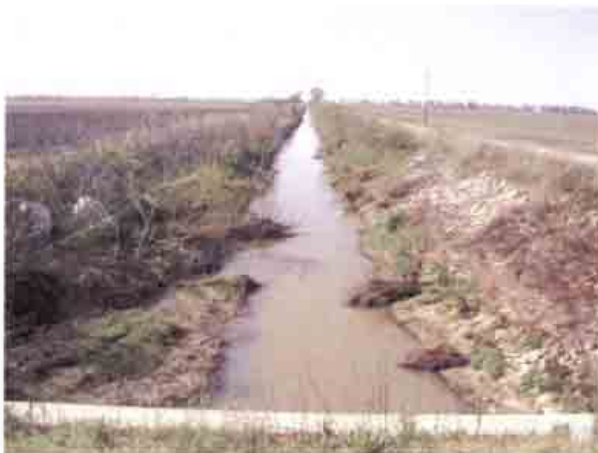
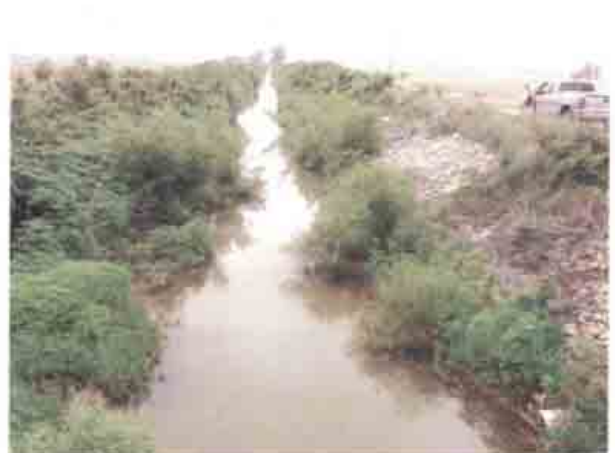
Site # 2 - Jct of Co Rd 779 & Co Rd 784

06/03/05 - Stream assessment was taken from the bridge on this date due to snakes being too numerous and aggressive to safely enter stream. Depth measurements were taken from the bridge and were estimated to be approximately 45 cm deep – based on visual assessment.

Site #2: Site #2 of Ditch #8 is located at the junction of County Road 779 and County Road 784. Farm fields surround the area, and there are two residences within walking distance. The water body has very steep banks and dense to moderately dense bank vegetation at this site making access difficult. During the June 3rd visit, two large snakes were observed in the water, and only a visual assessment was conducted.

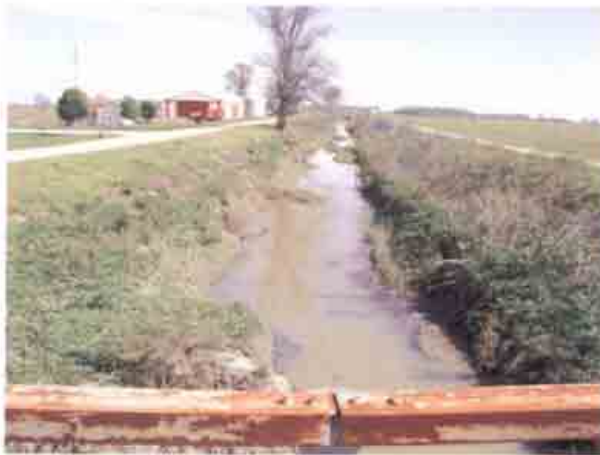
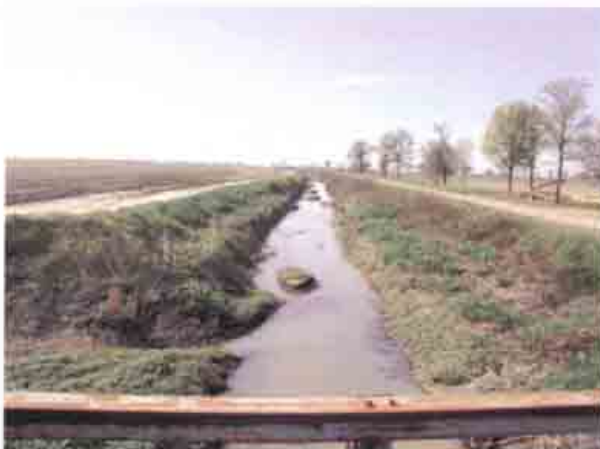
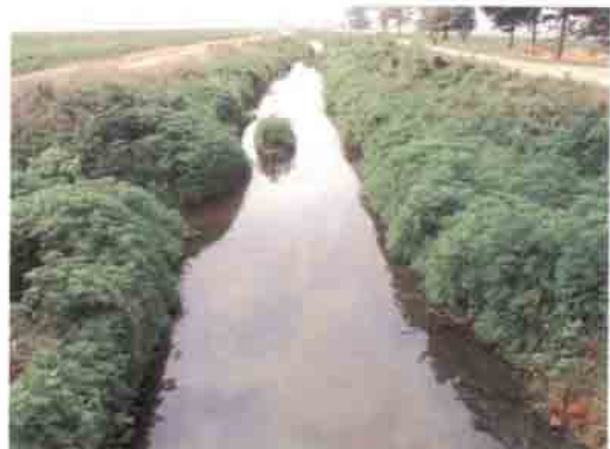
Site # 3 - Off Hwy Z & Co Rd 779

04/16/05 - thick layer of fine sediment on the bottom of the ditch was noted.

Site #3: Site #3 of Ditch #8 is located at Highway Z and County Road 779. Farm fields surround the area, and there is one residence within walking distance. A considerable amount of trash was noted on the banks of the water body.

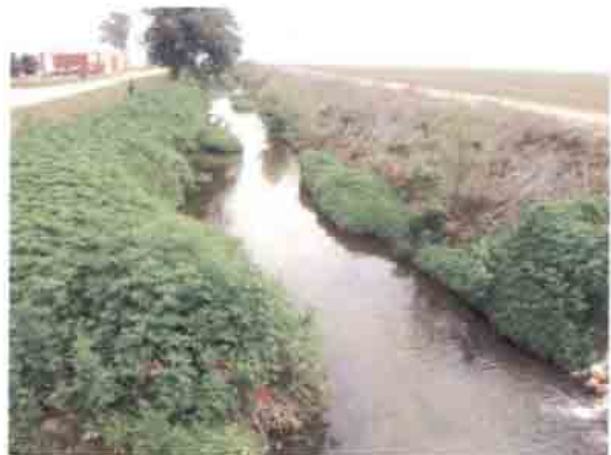
06/03/05 - Irrigation return flow can be seen in upstream view picture on this date entering the stream from a drainage pipe.

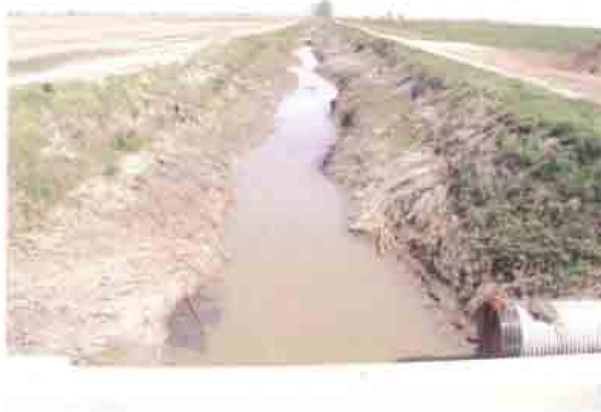
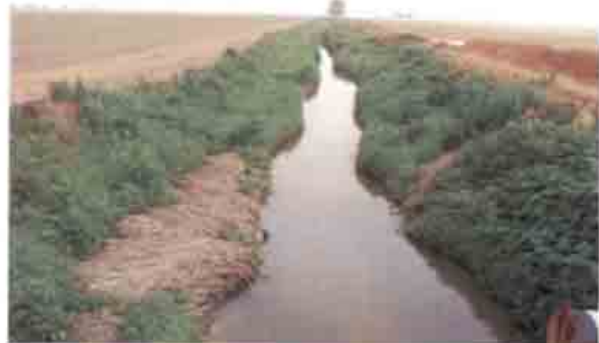
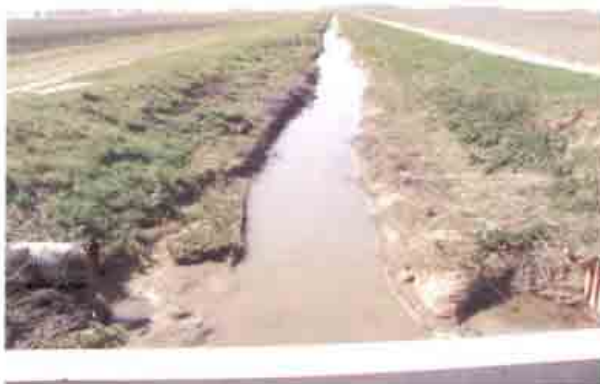
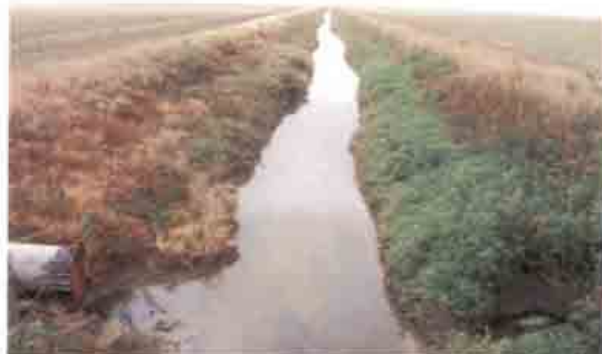
Site # 4 - Hwy D

06/03/05 - Several rotting animal carcasses were discarded on the bank of the water body.

Site #4: Site #4 of Ditch #8 is located on Highway D. Steep banks line the water body, and the surrounding area consists of farm fields.
